BUILDING EVALUATION REPORT FOR:

## CANNON BEACH ELEMENTARY SCHOOL

PREPARED BY ZCS ENGINEERING & ARCHITECTURE

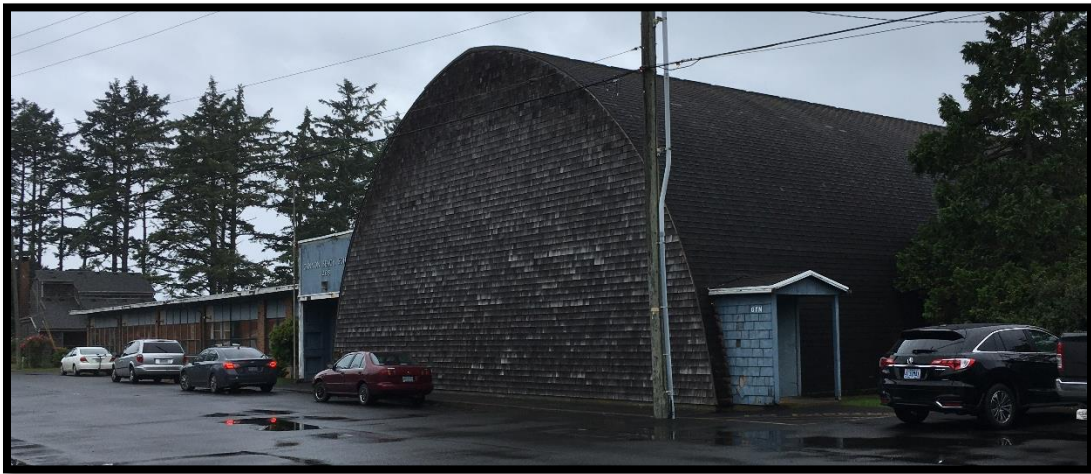
Figure 1: Cannon Beach Elementary Main Building and Gym

The Classroom wing was built in 1950 and contains classrooms and restrooms with an approximate footprint of 4,600 square-foot. The original structure was constructed out of 2x framing lumber for all entire and exterior walls. The exterior walls contain a large number of windows. The roof consists of straight sheathing over 2x12 rafters bearing on interior and exterior walls. The foundation consists of a concrete slab-on-grade with cast-in-place concrete stem walls and footings.

A 7,300 square-foot gymnasium with a 1,050 square-foot mezzanine to the east of the original school was constructed in 1952 and consist of arched glulam rafters that make up the roof and walls. The roof framing consists of a combination of skip sheathing and plywood on the arched glulams. The foundation consists of a concrete slab-on-grade with cast-in-place concrete stem walls and footings. A small covered walkway connects the gymnasium to the classroom wing.
